# Analysis on Quenching Cracks of Engine Crankshaft

**Abstract:** Engine crankshaft of cracks macro and micro were analyzed by morphological characteristics and quench cracks organization identified as the quenching crack, but further study showed that the root cause of this quenching cracks generated not due to the heat treatment process or other causes, but due to poor uniformity of the hot iron casting, elements gathered along the grain boundary segregation.

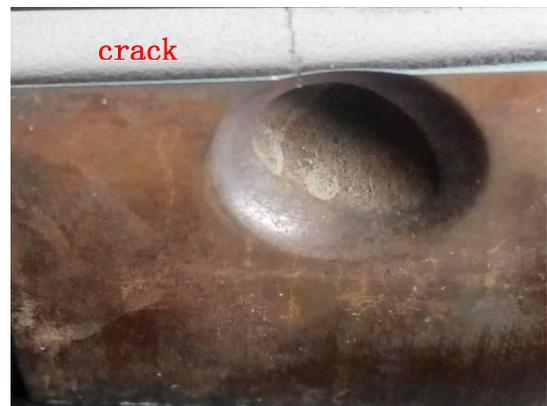
Observe all cracks in the crankshaft, found that the crack is located in the connecting rod and spindle oil hole chamfer position and the bottom of the thinnest wall, and to the oil hole chamfering the inner wall and journal extension shown in Figure 1.

Fig.1.crack macroscopic morphology

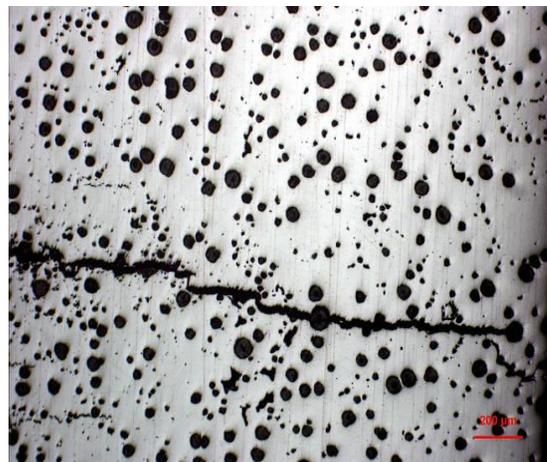
Fig.2.crack micro-morphology(50X non-corrosive)

The microscopic detection of the opening of the oil hole crack. Figure 2 and Figure 3 show the microscopic morphology of the crack. .It can be seen from Figure 2 that although the main crack is sometimes broken in the middle, but the overall look at the main cracks originated in graphite. The crack passes along the graphite, and the main crack shape is strong and powerful. Cracks seem to tear because of force, and the direction of straight. Some small cracks originate in graphite, tail tip.

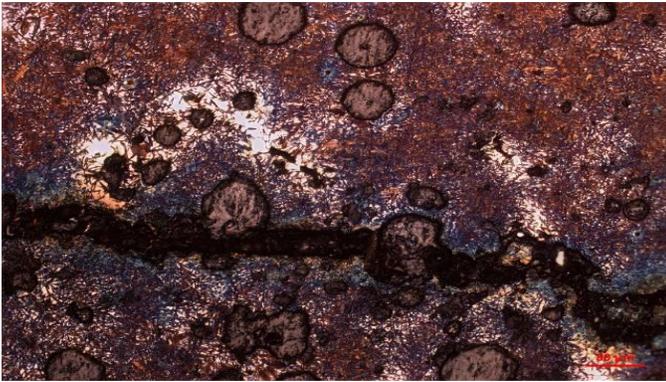
Fig.3.crack micro-morphology (200X has been corroded)

In order to better observe the characteristics of the crack shape, the oil hole crack cut with 5% nitric acid alcohol solution corrosion observation [2], found that the crack through the graphite, graphite shape intact, crack along the edge of the graphite line, rather than from Graphite through.

Ductile iron workpiece quenching cracks for many reasons, such as improper cooling, inclusions, spheroidization, complex parts and the quenching temperature is too high [3]. The quenched crack in Figure 3 is due to two stresses, ie, thermal stress and tissue stress. The former is caused by uneven cooling, the latter is austenite into martensite generated. When quenching and cooling, these two stresses tend to concentrate at the edge of graphite and cause cracking.

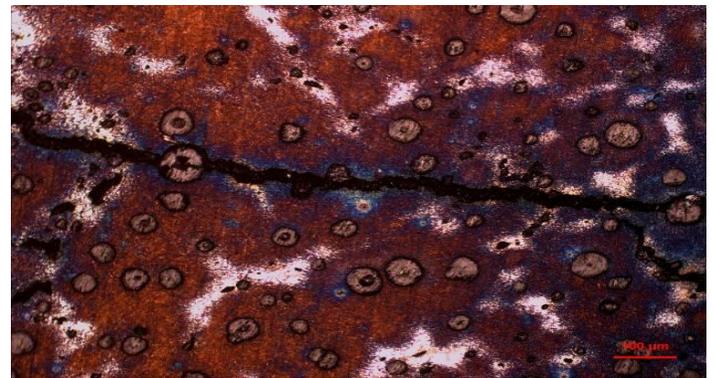
The main crack on both sides of the phenomenon of non-oxidative decarburization, it can be sure there is no crack before quenching (see Figure 4). During the quenching and cooling process, the crack may form only when the martensitic transformation reaches a certain amount. Corresponding to this temperature, about 250 °C below. At such a low temperature, even if cracks are generated, decarburization and significant oxidation not occur on both sides of the crack. Therefore, the phenomenon of oxidation decarburization is non-quenched crack. If the crack is already present before quenching and does not communicate with the surface, such internal cracks will not produce oxidative decarburization, but the lines of the crack appear soft, the tail is round bald, The lines of this crack are also easily different from the lines of the quenched crack,this crack are also easily different from

Fig.4. crack near the quenching organization (100X has been corroded)

Figure 4, Figure 5 quenching area of the microstructure to detect, microstructure characteristics are as follows:

- (1)Residual austenite content> 10% at 100X;(2)most of the small graphite along the grain boundary distribution;
- (3)residual austenite along the small graphite distribution;

According to JB/T 9205-2008 "pearlitic ductile iron parts induction quenching metallographic examination" on the quenching area to determine the organization: quenching organization 2-3; coarse martensite, large block retained austenite, cementite, Spherical graphite. Conclusion: Quenching tissue is not qualified.

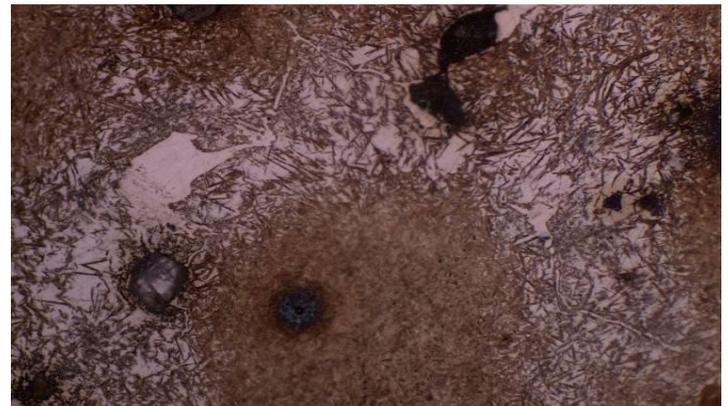
Fig.5. crack near the quenching organization (500X has been corroded)

(4)500X under the observation of a network of cementite along the grain boundary distribution; (5)residual austenite and cementite area martensite coarse; (6)the white area is a mixed structure of retained austenite and carbide.
